**FIFTEENMILE BASIN  
HABITAT IMPROVEMENT PROJECT**

**1992 ANNUAL REPORT**

Mt. Hood National Forest  
Barlow Ranger District  
Dufur, Oregon

Andy Thoms, Project Manager  
U.S. Department of Energy  
Bonneville Power Administration  
Division of Fish and Wildlife  
Agreement Number: DE-AI79-84 BP16726  
Project Number: 84-11

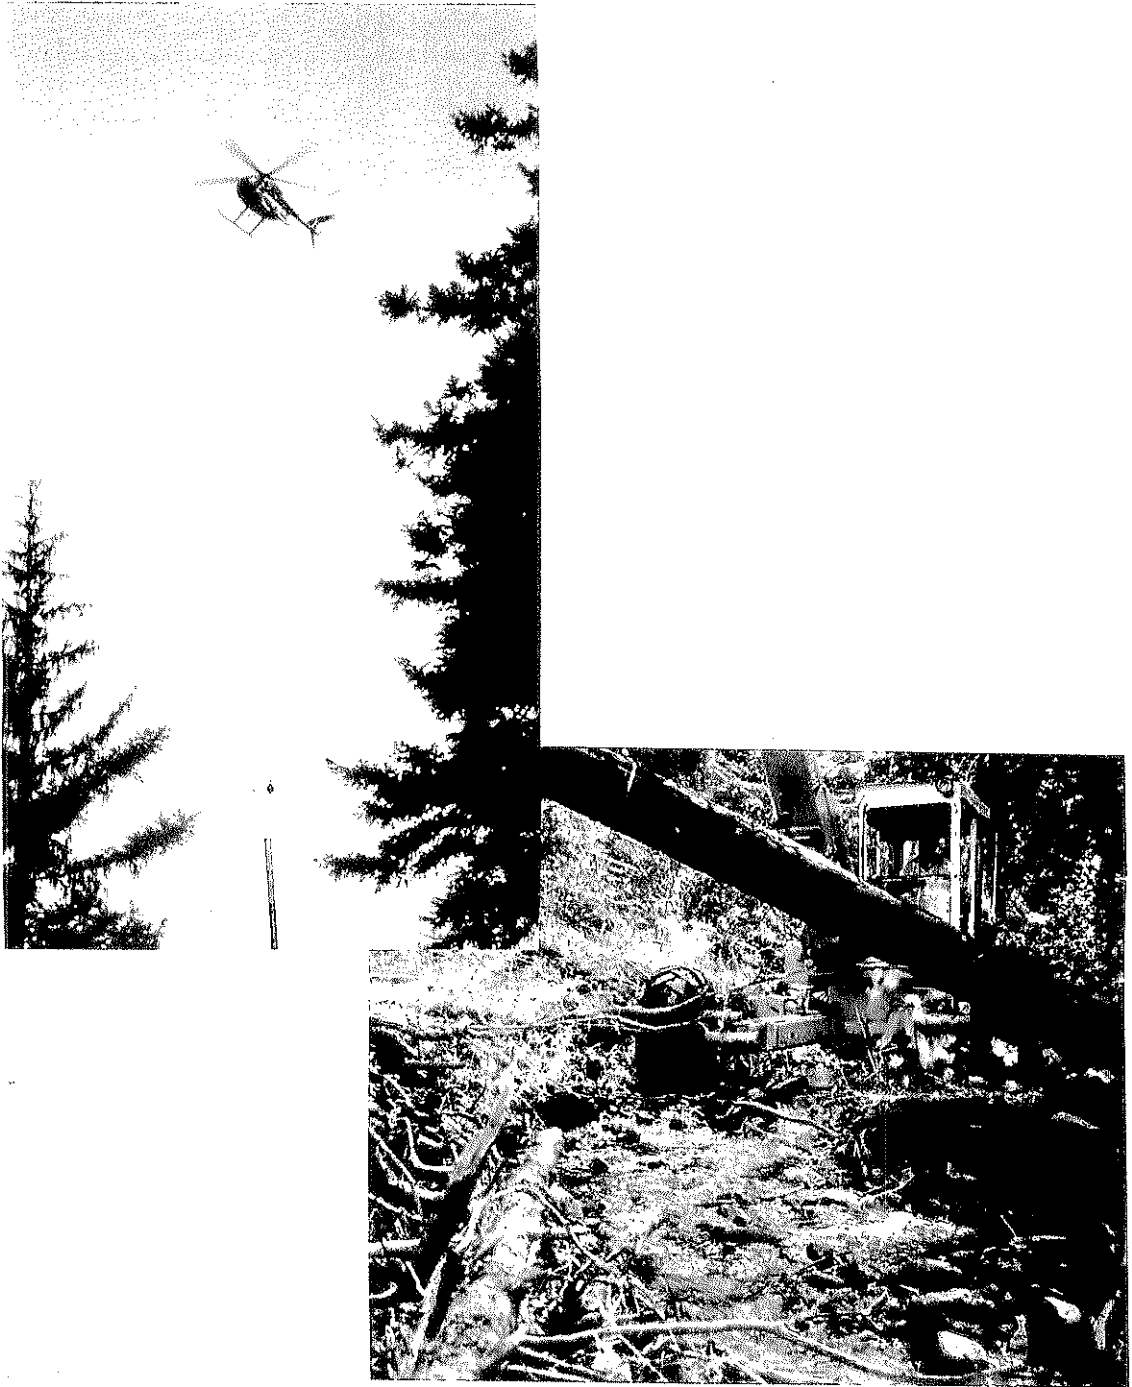
Helicopter delivering log to section one (top) and spyder excavator moving log for placement in Ramsey Creek (bottom).

We obtained logs for section one using a self loading log truck that picked up roadside blowdown trees located within the Barlow Ranger District. The logs, and about ten root wads, were decked on a ridge top just south of Ramsey Creek near the forest boundary. To minimize resource damage the logs were flown in by a helicopter directed by USFS personnel on the ground. We bucked the logs to the desired length prior to moving them into the drainage.

The spyder built instream log and/or boulder structures directed by district fisheries personnel. Sites selected for treatment were generally shallow pools or glides that lacked depth and/or cover; many sites were located within logging corridors. The spyder excavated below the gradient break, at the head of the pool or glide, and deposited the fill on the downstream riffle. In this manner the gradient of the site was maintained and the existing pool/riffle sequence was essentially unaltered. We did not place logs or boulders as upstream hydraulic controls at every site, only where bank conditions warranted placement. Most logs and boulders placed as upstream controls were in the form of diagonal sills or berms, respectively. Structure height was very low, so as to not back up water and flood the riffle upstream from the excavated pool. Generally, logs were keyed into the bank and cobble fill was placed along the upstream side to seal the structures. We added extra logs and sometimes boulders in pools as cover. Many logs were further anchored by cabling to boulders or trees.

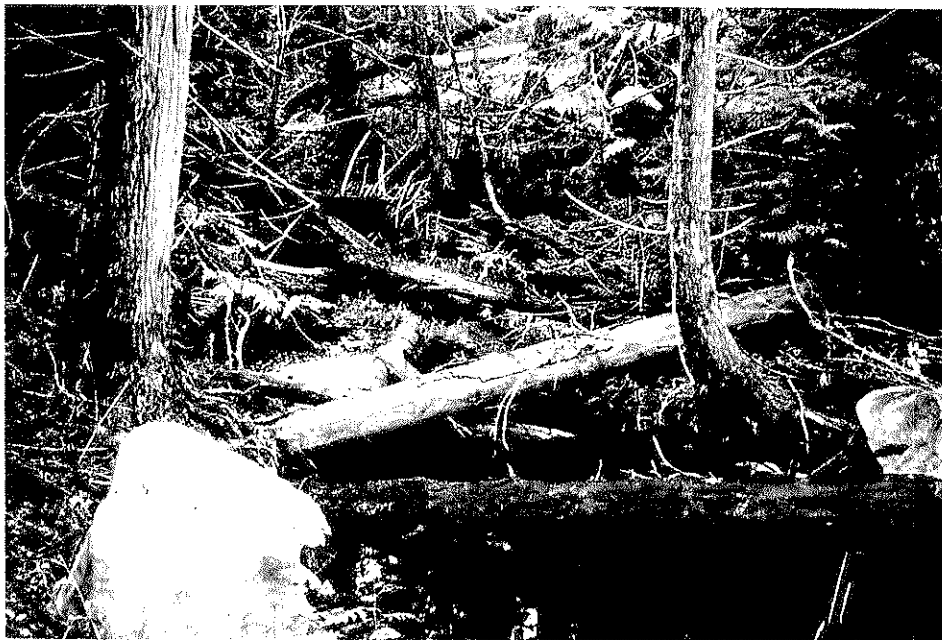
Before (top) and after (bottom) implementation photos of site 28 taken from downstream. The post implementation photo was taken from further away than the pre implementation photo.

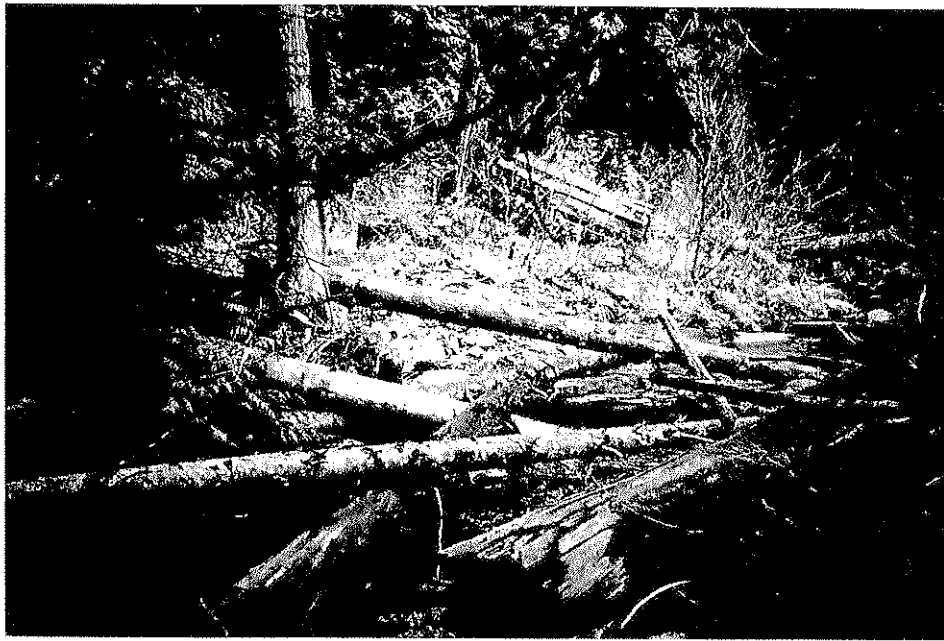
Pre and post implementation shots of site 24 taken from upstream. Post implementation photo was taken from a slightly different angle.

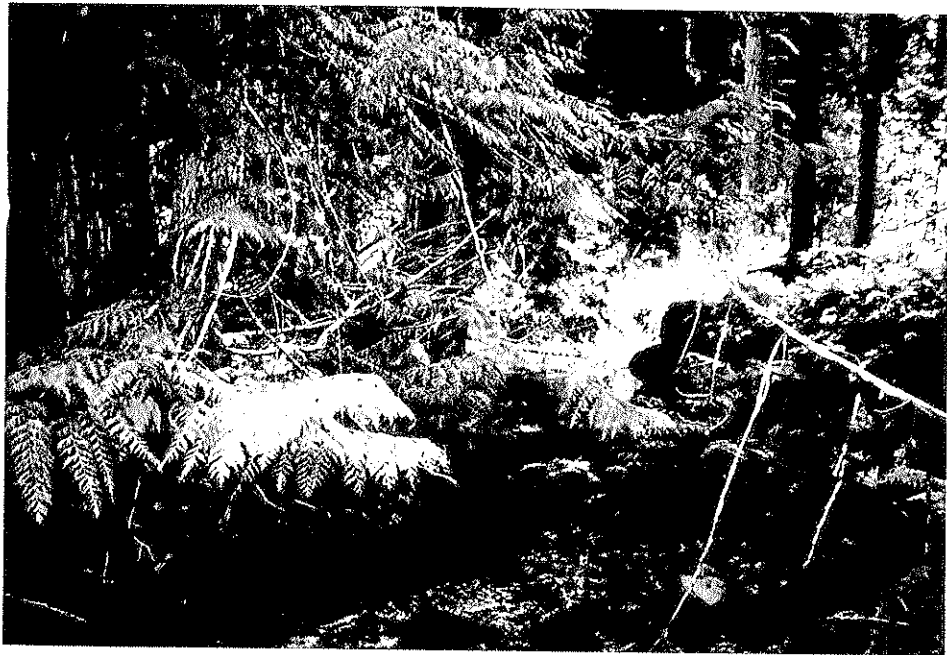
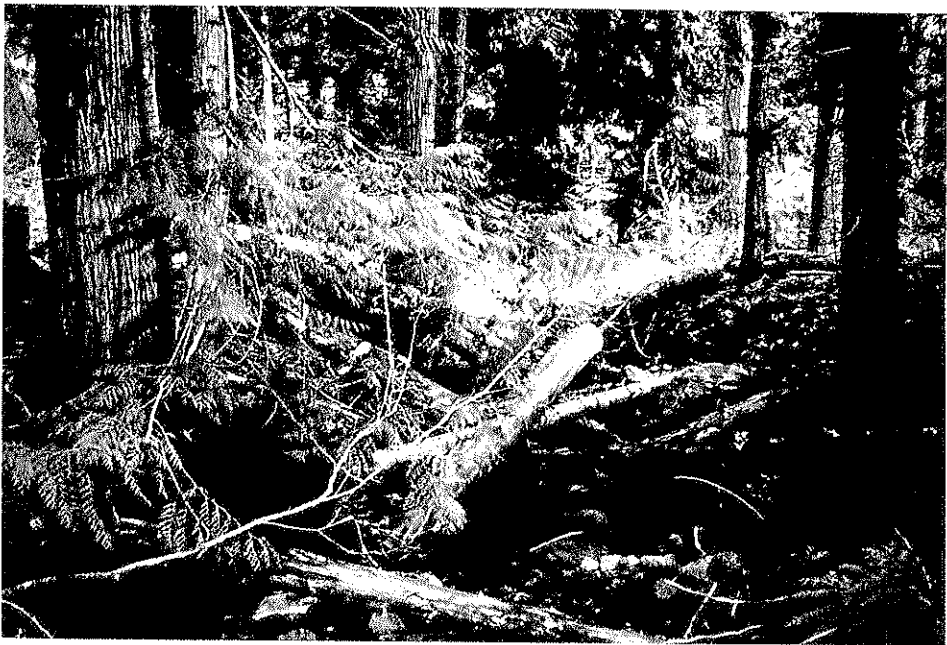
Pre and post implementation photos of site 23 taken from upstream. This site was one of our more intensive debris loading efforts.

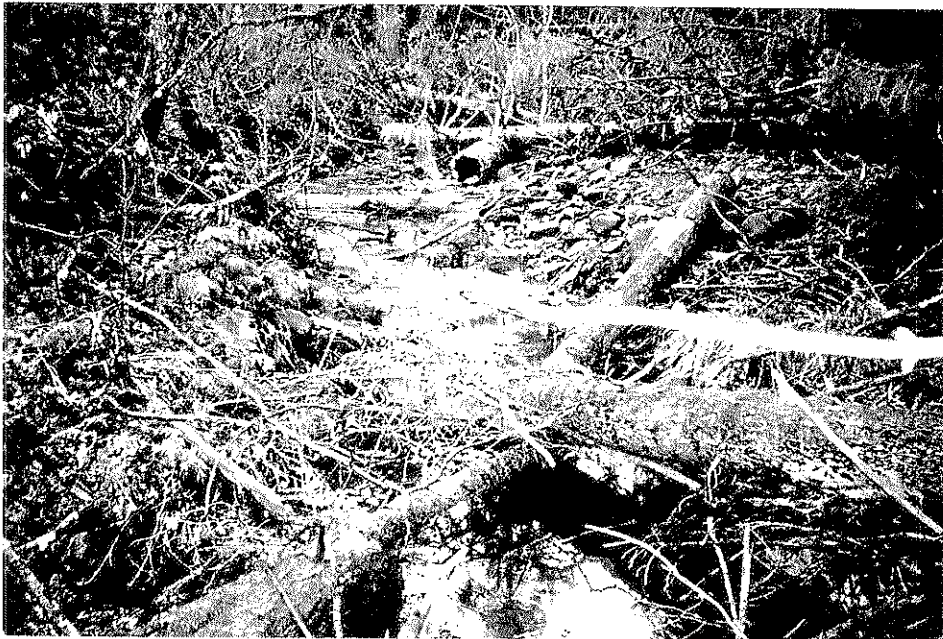
Pre implementation photo of site 8 (top) and post implementation photo of sites 8 (foreground) and 9 (background). Apparent lack of riparian vegetation in bottom photo due in large part to the photo timing after leaf drop.
